Educational Assessment

Introduction

Okemos High School

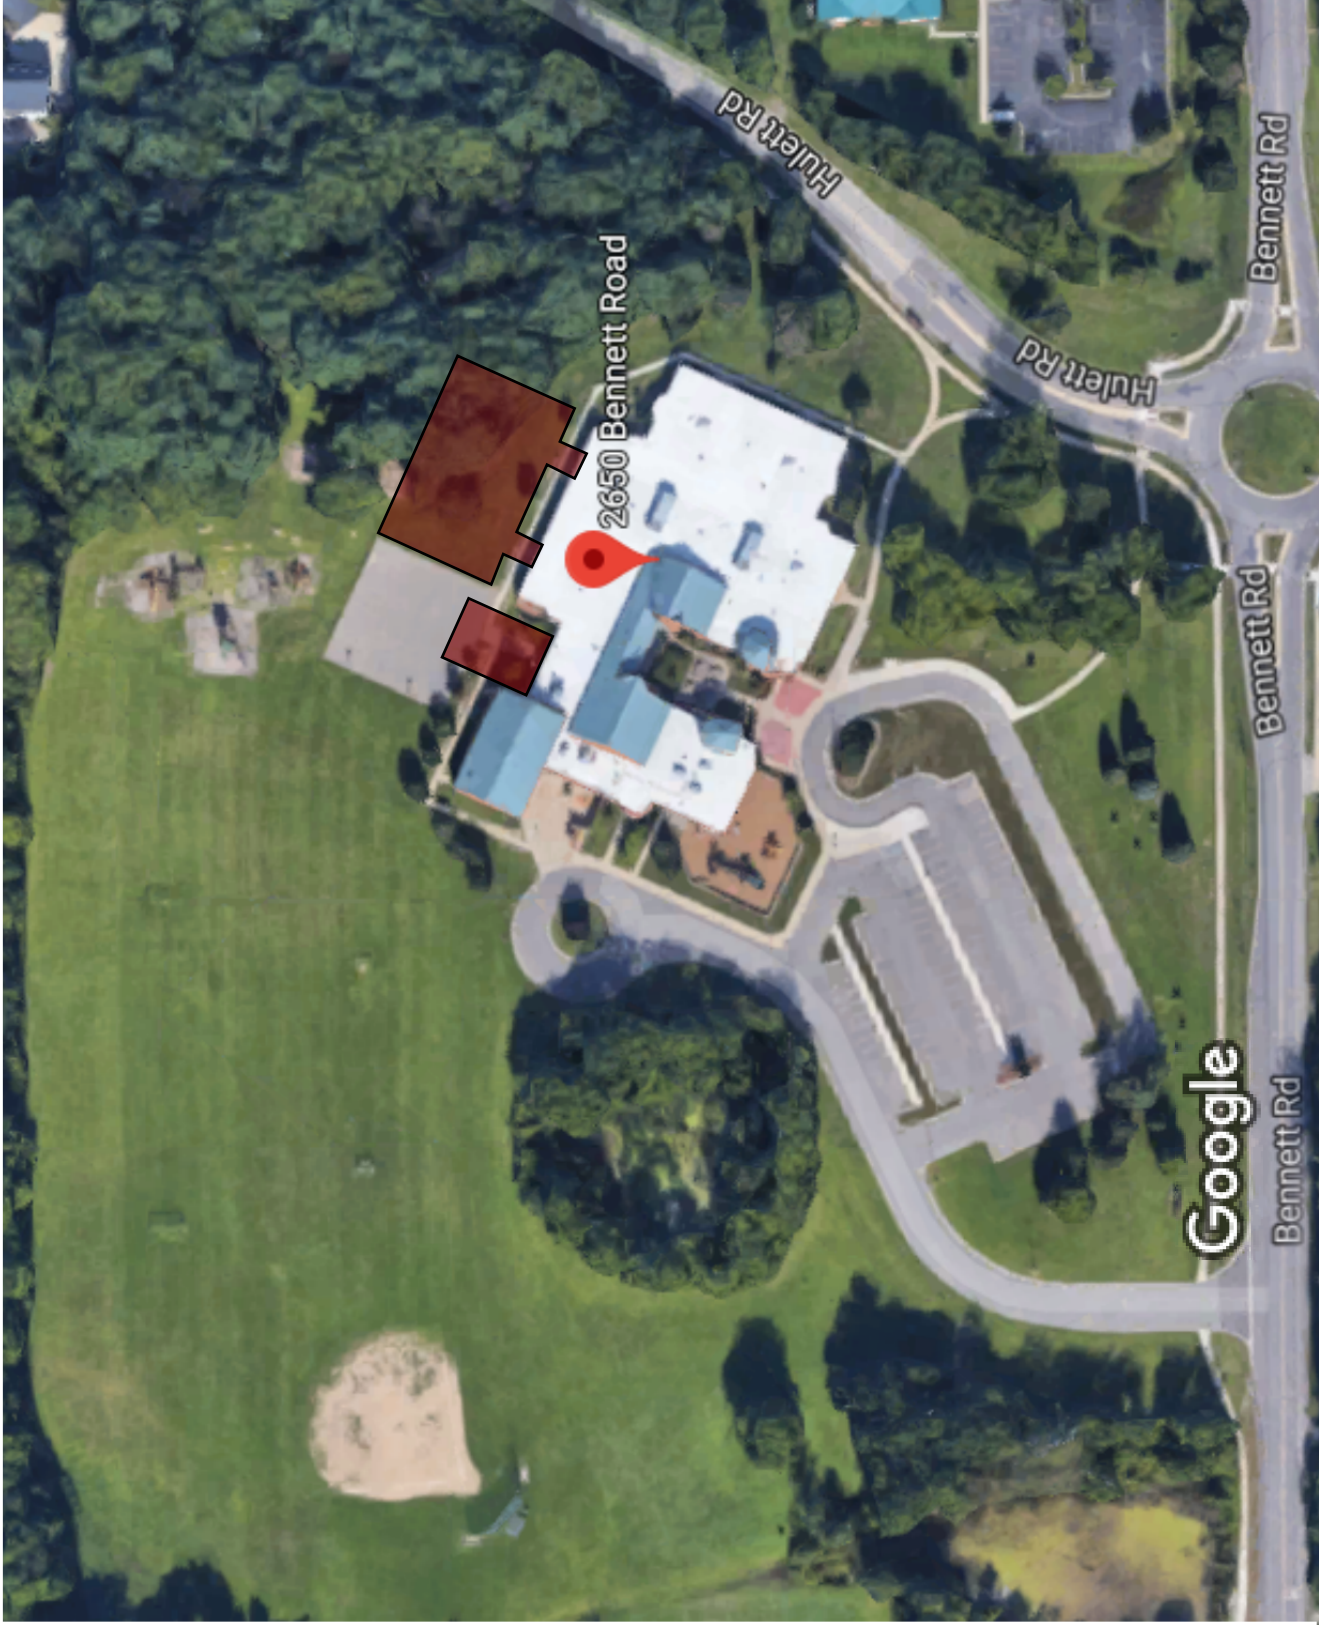
Bennett Woods Elementary

Area of Possible Addition
